No:	SB 277 -24	Issue:	1
Date:	17/9/24	Sheet:	Page 1 of 1

SUBJECT: Elite 6 / Elite+ Condensation in Headlights

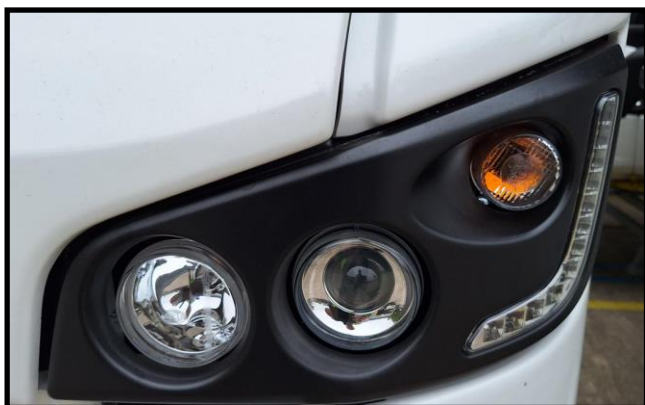
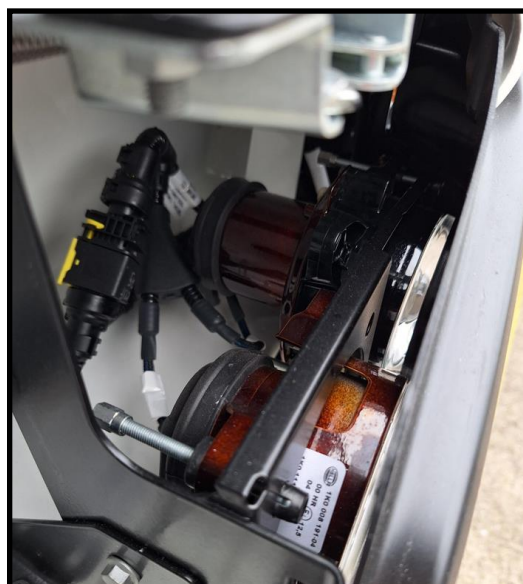
Headlamps have been sent back to the supplier with condensation/water present in the lamps, upon inspection water marks show the rubber cap was not fitted all the way over the ridge which leads to water ingress into the lamps.

Fig 1. Ensure that cap is pushed on fully over the ridge.

If you come across any headlamps with water present, dry the lamp out and ensure the rubber cap is fitted correctly as per Fig. 1.
