SB189-18

Elite 6 Perceived Engine Oil Leaks within the Bell Housing Area

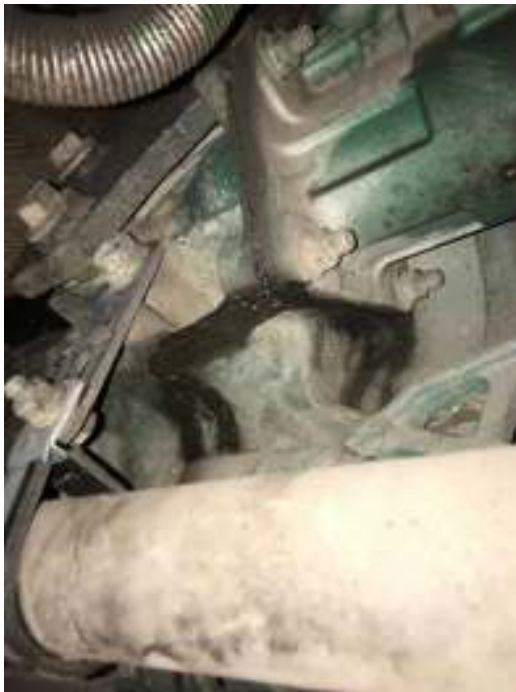
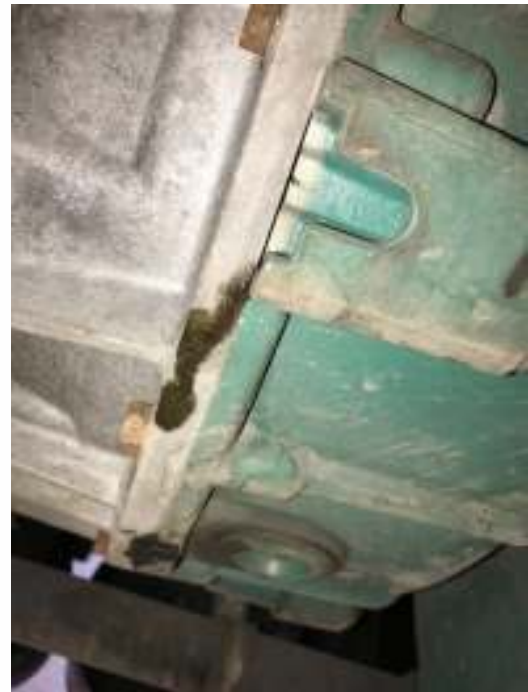
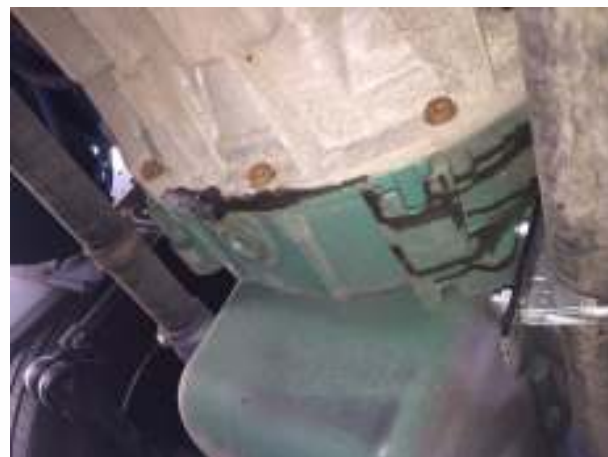
A small number of Elite 6 chassis have shown signs of oil leaks from the bell housing area as shown in the three images below.

Upon removal of the gearbox it was found the source to be a 'wax coating' applied to the gearbox torque converter. This wax coating is applied after manufacture to prevent oxidation during storage/transportation before fitment into the chassis.

It is recommended to clean this residue off by either steam cleaning or with brake cleaner.
