<b>No:</b>	<b>SB226-24</b>	<b>Issue:</b>	<b>1</b>
<b>Date:</b>	<b>02/04/24</b>	<b>Sheet:</b>	<b>Page 1 of 4</b>

**SUBJECT:** Dennis Elite Second Steer (ETS) Trailing Arm Bush Design - Checks

This document is written to help understand the design and methods used to check and determine if replacement is required of Dennis Elite second steer trailing arm bush/silent block fitted to ETS axles.

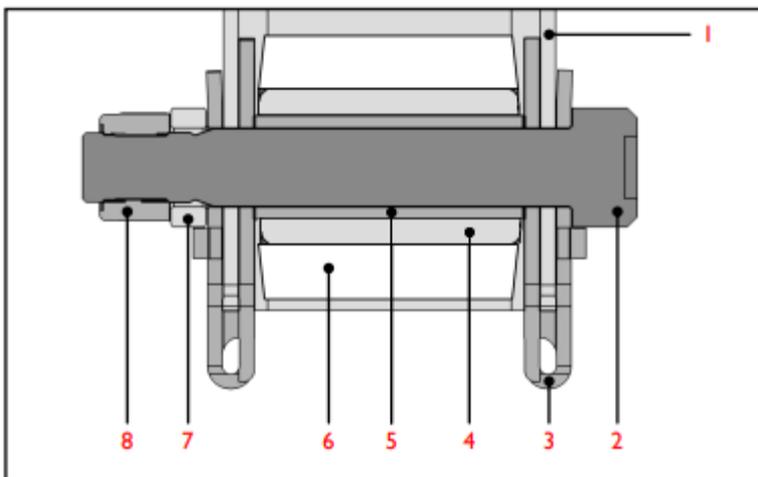
Fig. 2

If there is a gap between the rubber and the inner bush, or the rolled spring eye of the trailing arm the silent block must be replaced.

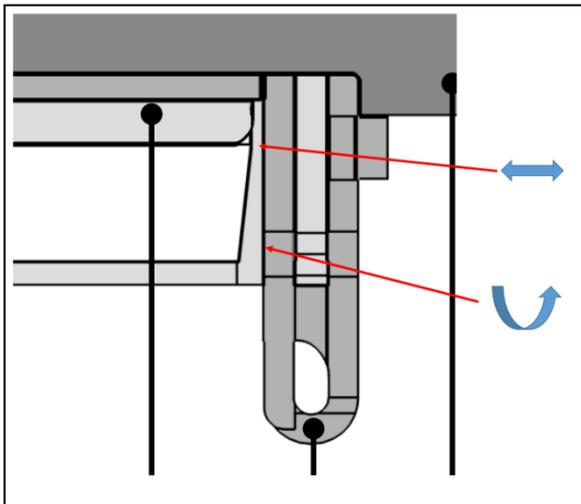
In Fig. 3 you can see the space between the rolled spring eye of the trailing arm and the wear plates.

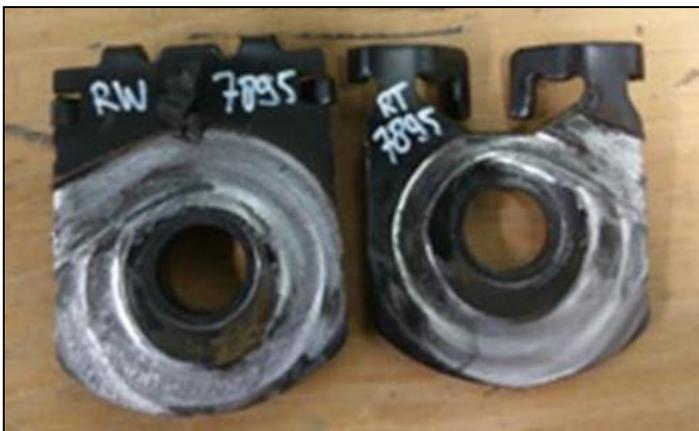
3. Melted rubber, or rubber particles around the rubber steel bush indicate that the bush must be replaced.
4. Excessive wear of the wear plates is also an indication of worn silent blocks, see Fig. 4 as an example, (these parts were used in an internal test), replacement would be necessary.
5. If the Clamp Bolt is loose (loss of the pre-tension), it could be a sign of wear in the silent block/clamp plates. Always check the torque and re-tighten if required, 800 – 850 Nm, 590 – 627 lb-ft.
