SB204-21

Elite 6 Engine ECU Mount Improvement

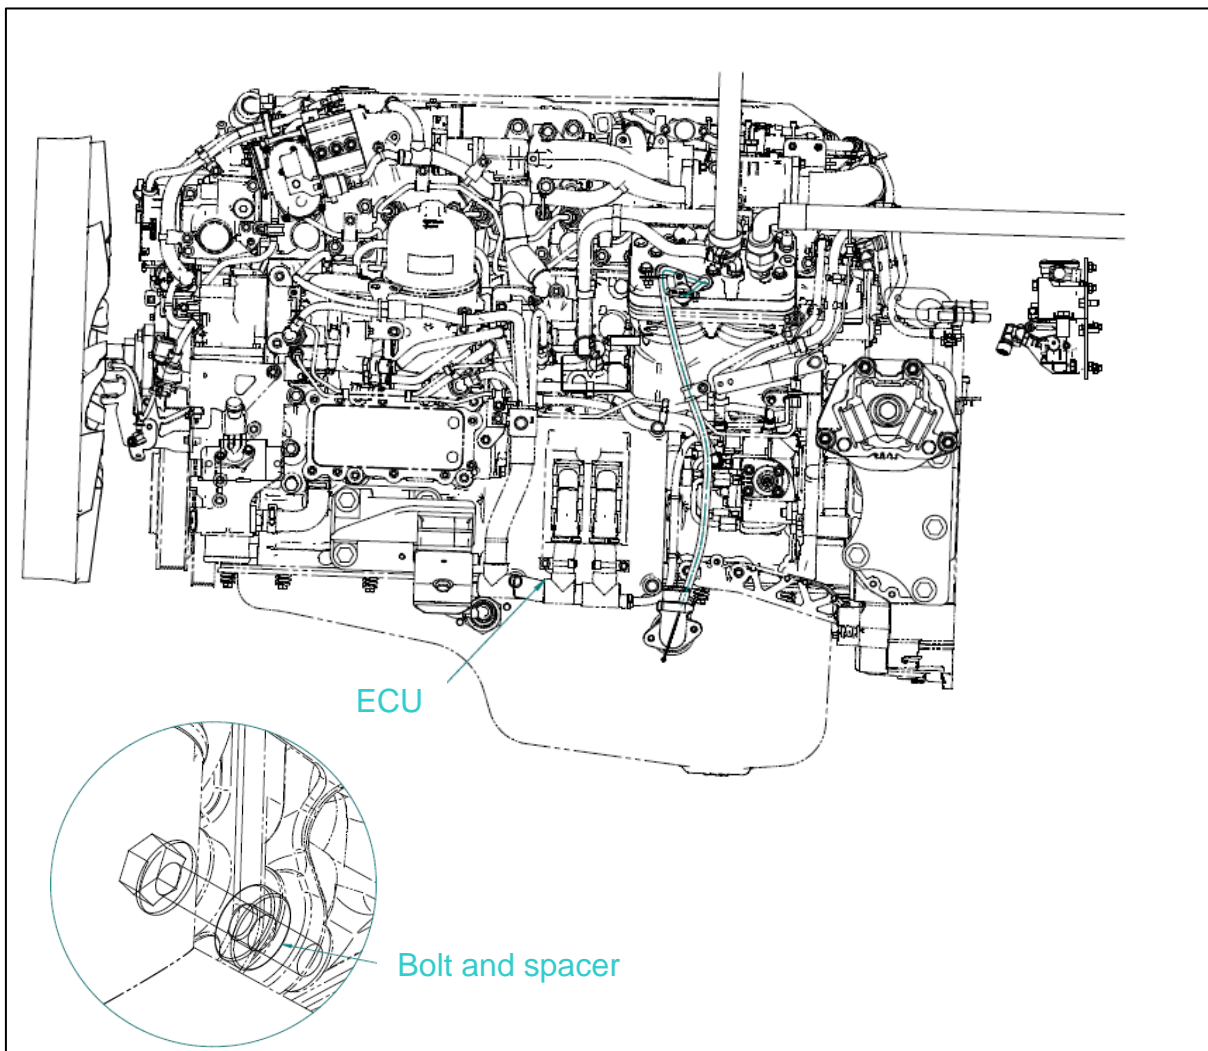
It is possible on the Elite 6 for debris e.g. stones to make their way into the area behind the engine ECU. If the stones do not work their way out it is possible for them to rub through ECU causing irreparable damage.

Fig. 1 below shows the position of the engine ECU and the spacer positioning.

To overcome this problem a simple fix is in place to space the lower rubber mounts out by adding 6mm spacers and longer bolts, production vehicles leaving DE are to this standard.

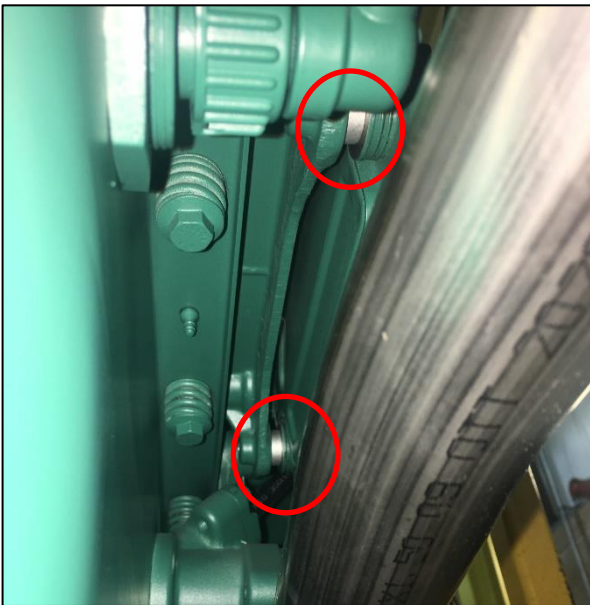
Fig. 2 shows the spacers mounted.

Bolts should be torqued to 25 Nm.

To apply this upgrade order part number SL1277 from DE parts on 01926 458555.
