SERVICE BULLETIN

No:	SB219-23	Issue:	1
Date:	05/04/23	Sheet:	Page 1 of 2

SUBJECT: eCollect LV Fusebox Maintenance

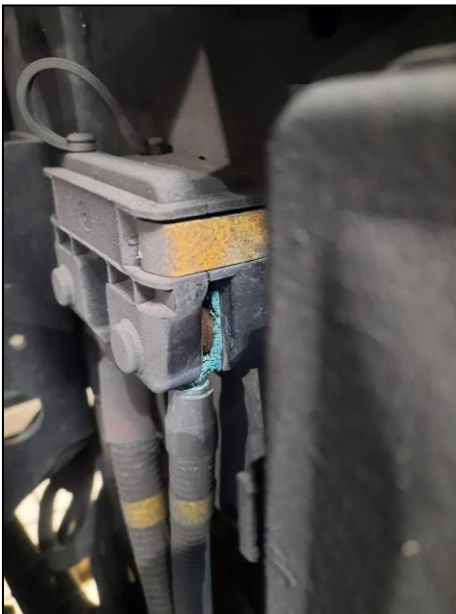
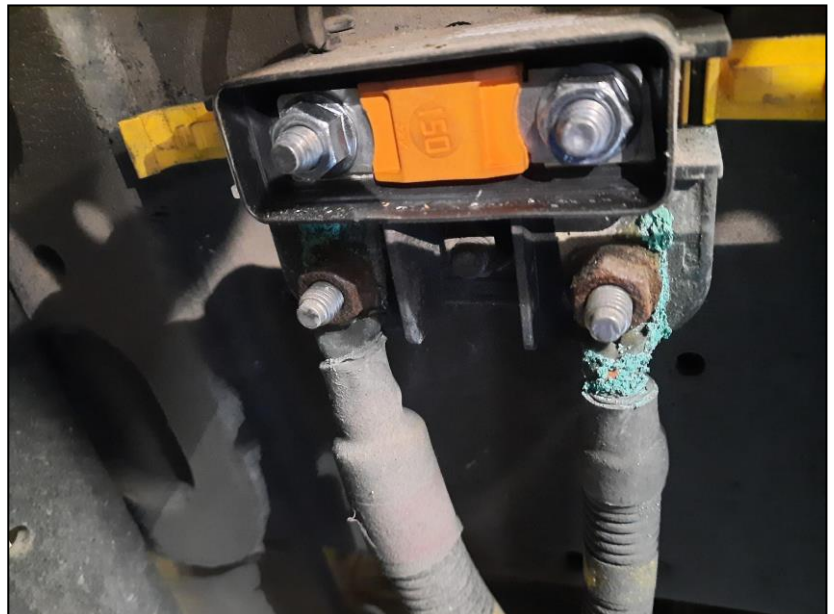
Fig. 1

We have seen isolated cases of corrosion on the main terminals of these fuse boxes which can lead to non-starts or unwanted shutdowns.

Fig. 1&2 below show an older 'type one' fuse box with corrosion to terminals, this is part number 1099427.

During inspection/servicing on the eCollect these connections should be checked, if you see any signs of corrosion to the Eyelet Terminals and/or Connection Studs, they should be disconnected, cleaned, and then reconnected. The maximum torque value for the Input and Output connection nuts is 20Nm. Once re-connected, 'battery terminal grease' needs to be applied to the outside of the connection and inside the red rubber boot if fitted to give protection against moisture.

Warning: There is a permanent 24V feed to these connections, they are not isolated when the battery isolator is in the off position. **DISCONNECT THE BATTERY CONNECTIONS BEFORE WORKING ON THIS LV FUSEBOX.**
