No:	SB 277 -24	Issue:	1
Date:	17/9/24	Sheet:	Page 1 of 1

SUBJECT: Elite 6 / Elite+ Condensation in Headlights

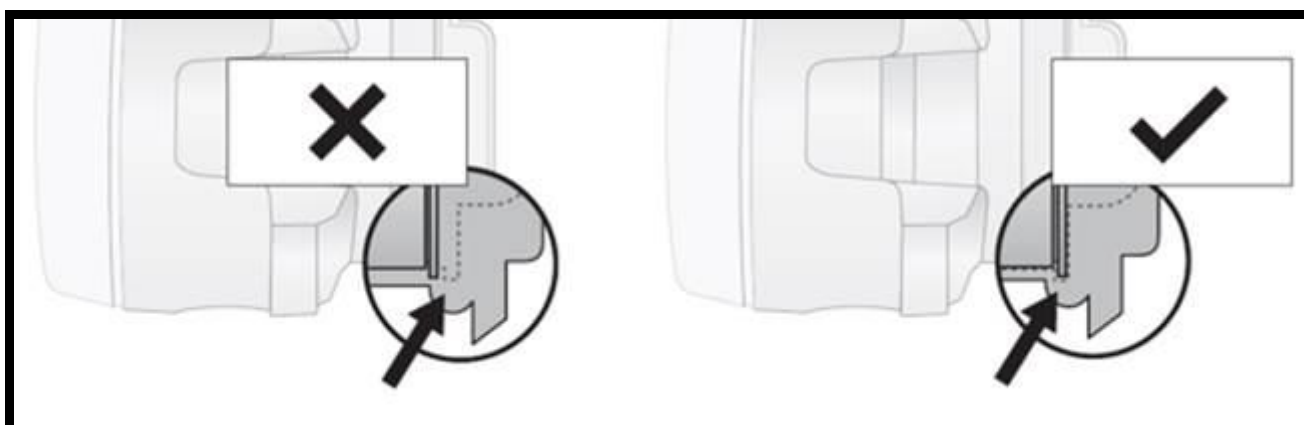
Headlamps have been sent back to the supplier with condensation/water present in the lamps, upon inspection water marks show the rubber cap was not fitted all the way over the ridge which leads to water ingress into the lamps.

Fig 1. Ensure that cap is pushed on fully over the ridge.

If you come across any headlamps with water present, dry the lamp out and ensure the rubber cap is fitted correctly as per Fig. 1.
