<b>No:</b>	<b>SB226-24</b>	<b>Issue:</b>	<b>1</b>
<b>Date:</b>	<b>02/04/24</b>	<b>Sheet:</b>	<b>Page 1 of 4</b>

**SUBJECT:** Dennis Elite Second Steer (ETS) Trailing Arm Bush Design - Checks

This document is written to help understand the design and methods used to check and determine if replacement is required of Dennis Elite second steer trailing arm bush/silent block fitted to ETS axles.

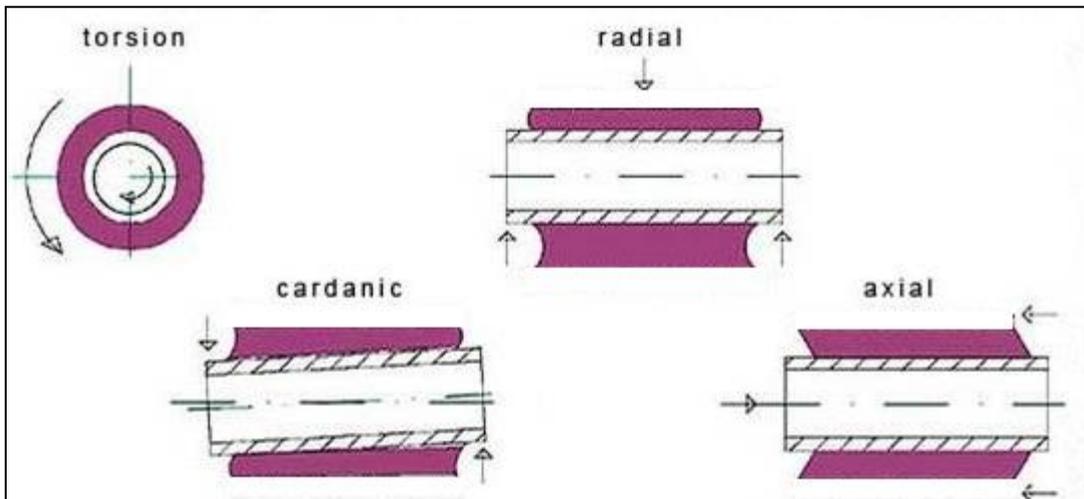
The design of the silent block makes it possible to achieve torsional, radial, cardanic and axial movement, see Fig. 1 below:
