SB184-18

Elite 6 Headlamp Bezel Breather Hole.

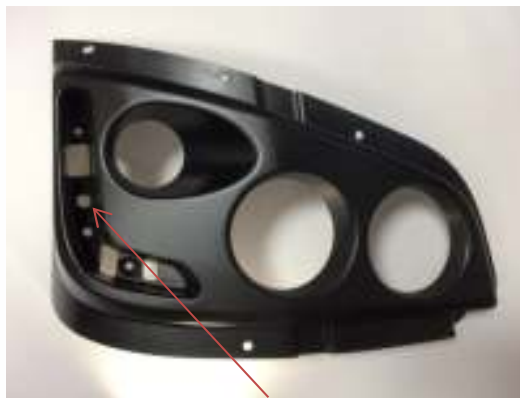
Breather hole

It has been brought to Dennis Eagle`s attention that we have been supplied, Elite 6 L/H and R/H headlamp bezels with a breather hole missing. It is recommended at the next service that the front DLR`s are removed and the bezel checked. The hole acts as a breather for the DRL and without it the DRL could suffer from condensation.

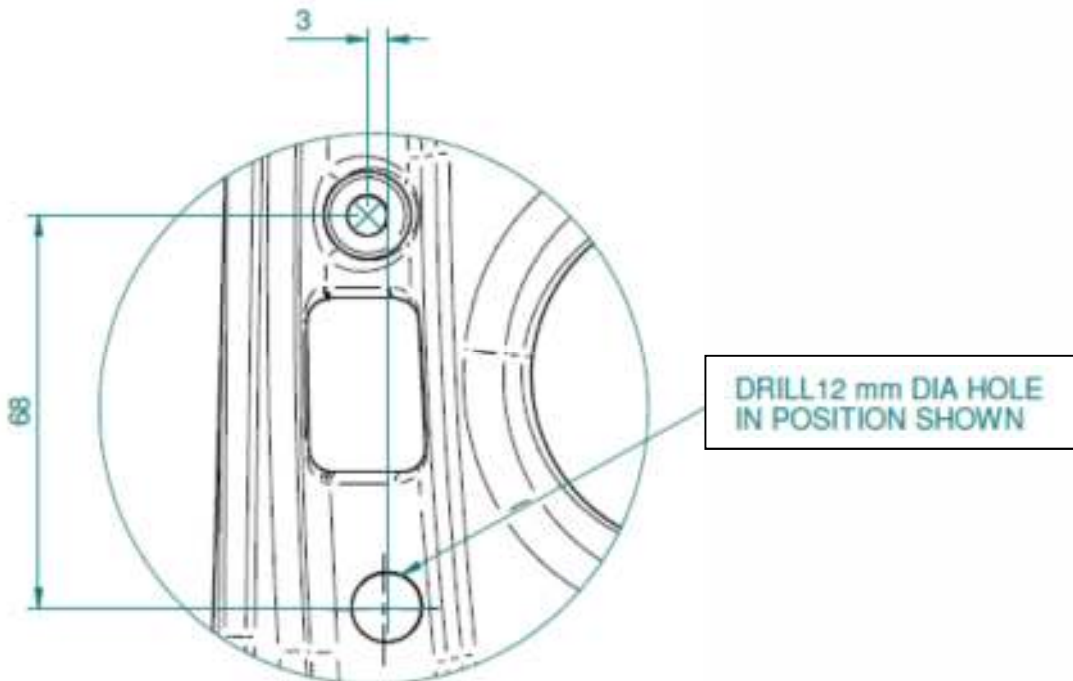
If the hole is missing the bezel needs to be reworked as shown below.

Please note: The illustration shows the R/H bezel, the dimensions need to be mirrored to rework the L/H bezel.
