SB 186-18

RCV Hot Weather Precautions

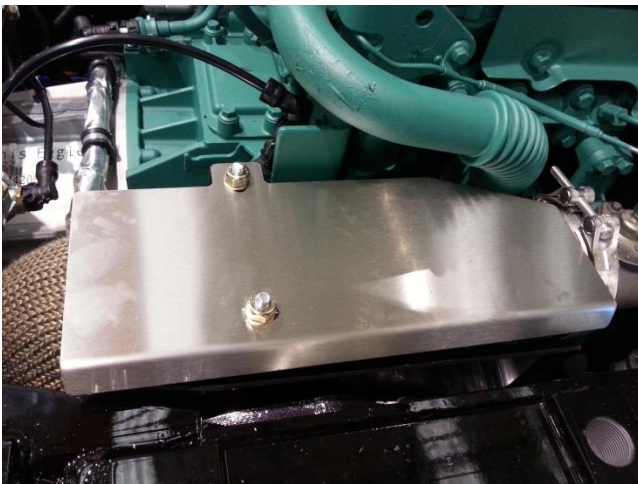
During hot weather care over cleaning of refuse vehicles is more imperative than ever. Refuse, hydraulic oil, leaves, twigs etc. that spill onto the engine bay/exhaust area can lead to a thermal incident.

- It is recommended these areas are inspected daily and addressed accordingly. Adding this element to drivers daily checks would be a good measure.
- It is important that all exhaust guards/socks are fitted to the exhaust without any visible damage.
- Exhaust joints and flexi pipes must be free from any leaks.
- Exhaust/Turbo guard should be fitted as per Fig. 1 below. This was raised as a campaign by DE back in March 2016 ref CP202 under Service Bulletin SB155-16. If you do not have this guard fitted please contact Dennis Eagle parts quoting SL1132 as a part number, the guard will be supplied FOC for you to fit at the earliest time possible.
